JOB COMPLETION REPORT  
AIR DIVING CAMPAIGN  
FOR  
SU TU NAU PRE INSTALLATION SURVEY PROJECT

**STN PRE INSTALLATION SURVEY  
PROJECT**

**AIR DIVING CAMPAIGN**

**Subject** : Survey the seabed around jacket installation positions of STN-N and STN-S jackets with the survey area 200mx200m

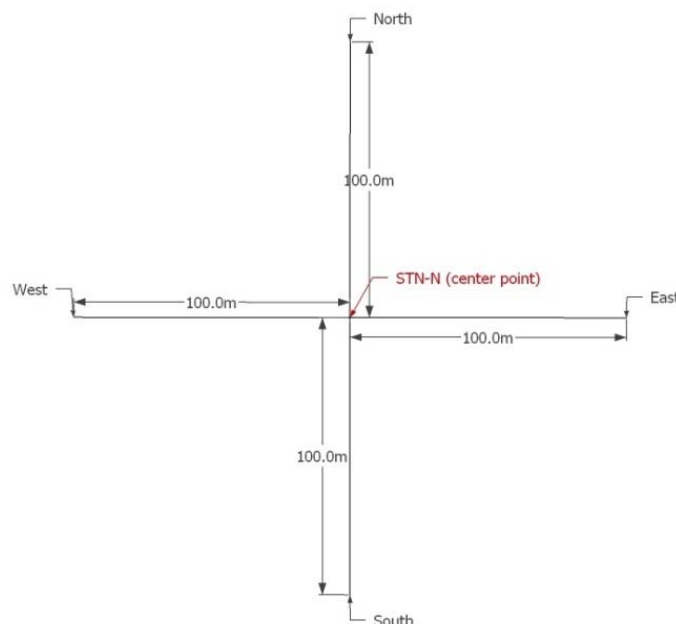
- Put STN-N coordinate (the center point of survey area) that is provided by Client to GPS navigation and position
- Determine and mark 4 points toward the East, West, South, North and the distance from the center point to each point is 100m

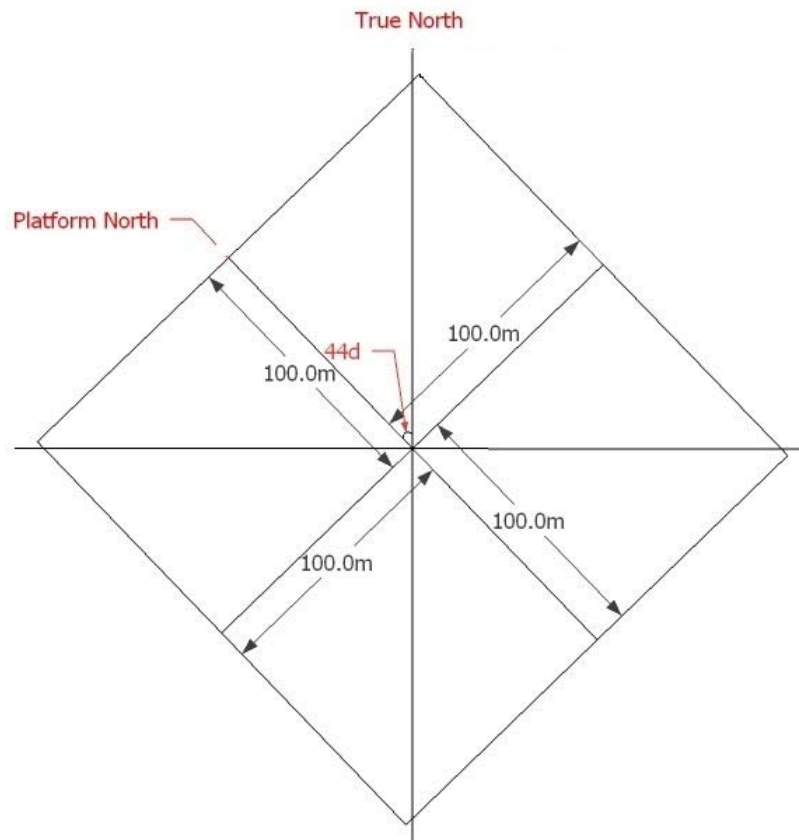
- Put STN-N coordinate (the center point of survey area) that is provided by Client to GPS navigation and position
- Determine and mark 4 points toward the East, West, South, North of jacket and the distance from the center point to each point is 100m
- ❖ **Note:** The Jacket North is deflected  $44^{\circ}$  with true North follow counter clockwise

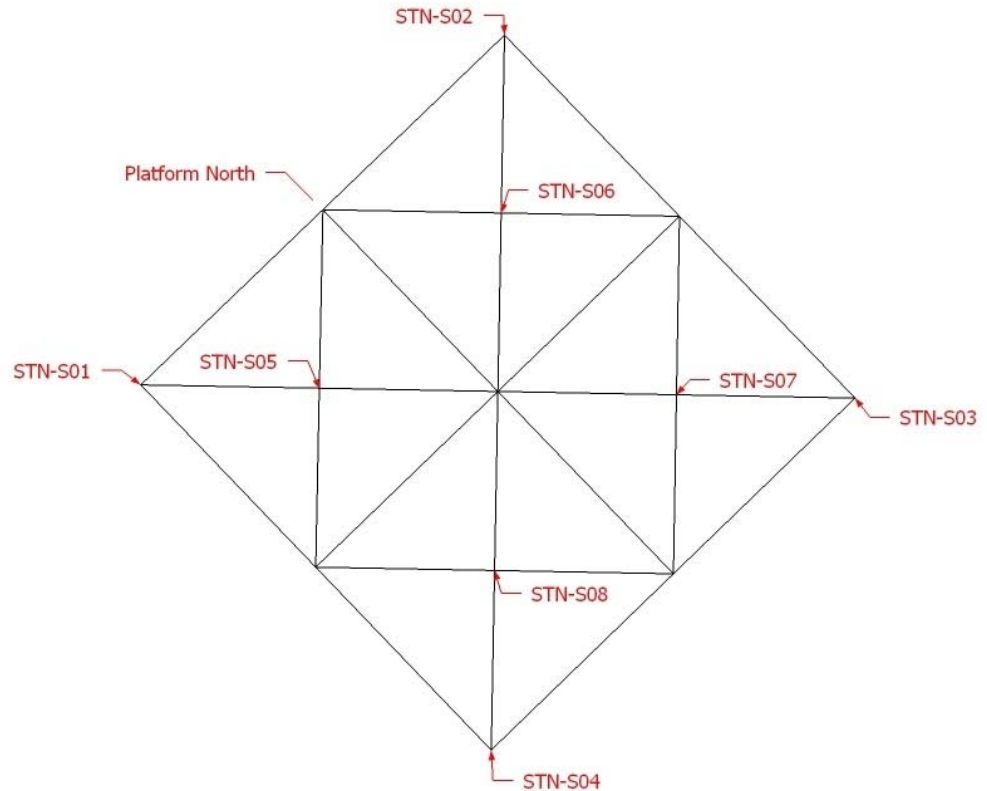
- Base on these 4 points, determine and making 8 points as below picture:

- The coordinate of above points:
  - o STN-S05: E 872233.300m – N 1168618.234m
  - o STN-S06: E 872305.23m – N 1168687.70m
  - o STN-S07: E 872373.47m – N 1168615.79m
  - o STN-S08: E 872302.77m – N 1168546.30m

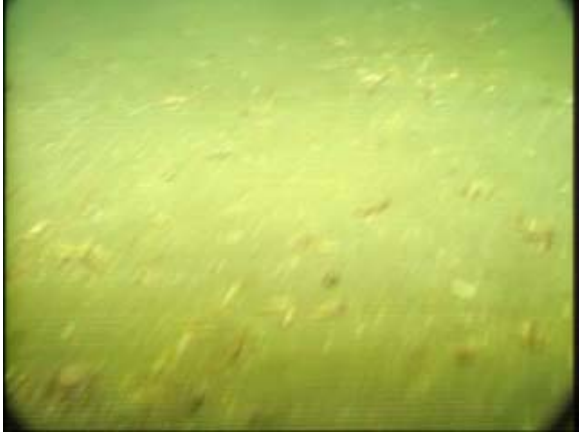
<p>06.30 – 07.20 14/08/2013</p>	<ul style="list-style-type: none"> <li>- Divers in water continue survey the seabed around the STN-N05 point within the radius 50, 55, 60, 65 meters</li> <li>- There are no any debris was detected</li> <li>- The seabed is a layer of hard sand under a thin layer of oyster shell, ephemeras and alluvium</li> </ul>

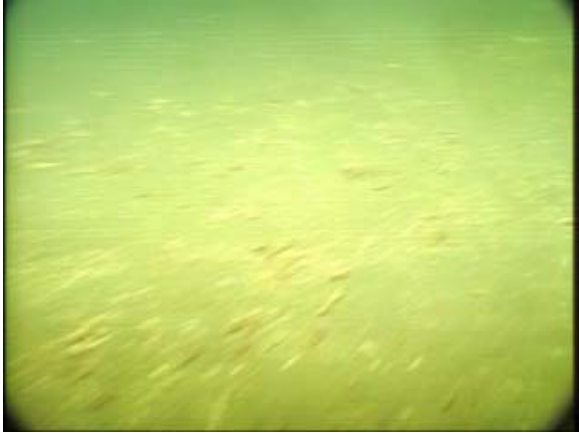
<p>07.25 – 08.30 14/08/2013</p>	<ul style="list-style-type: none"> <li>- Divers in water continue survey the seabed around the STN-N05 point within the radius 70, 75 meters</li> <li>- There are no any debris was detected</li> <li>- The seabed is a layer of hard sand under a thin layer of oyster shell, ephemeras and alluvium</li> </ul>

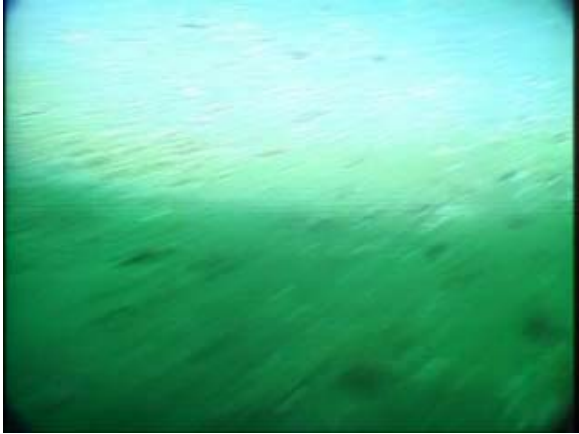
<p>08.35 – 09.40 14/08/2013</p>	<ul style="list-style-type: none"> <li>- Divers in water continue survey the seabed around the STN-N05 point within the radius 80 meters</li> <li>- There are no any debris was detected</li> <li>- The seabed is a layer of hard sand under a thin layer of oyster shell, ephemeras and alluvium</li> </ul>

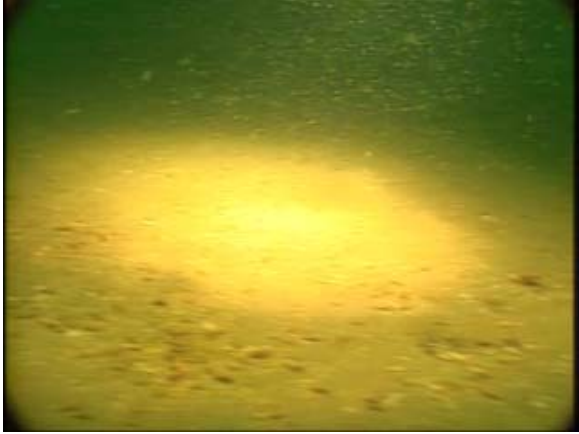
<p>14.30 – 16.00 15/08/2013</p>	<ul style="list-style-type: none"> <li>- Divers in water start survey the seabed around the STN-N07 point within the radius 15, 20, 25, 30, 35 meters</li> <li>- There are no any debris was detected</li> <li>- The seabed is a layer of hard sand under a thin layer of oyster shell, ephemeras and alluvium</li> </ul>

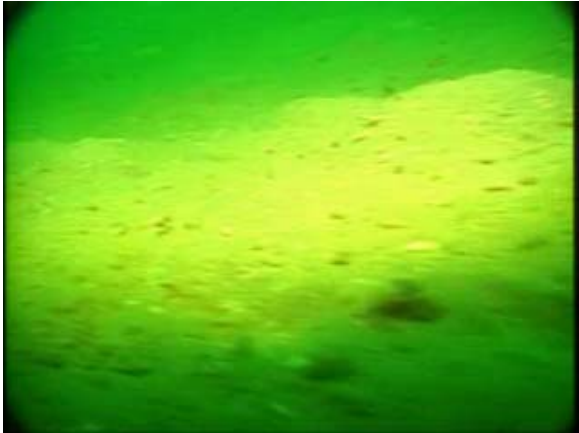
<p>07.00 – 08.20 16/08/2013</p>	<ul style="list-style-type: none"> <li>- Divers in water start survey the seabed around the STN-N07 point within the radius 40, 45, 50, 55, 60 meters</li> <li>- There are no any debris was detected</li> <li>- The seabed is a layer of hard sand under a thin layer of oyster shell, ephemeras and alluvium</li> </ul>

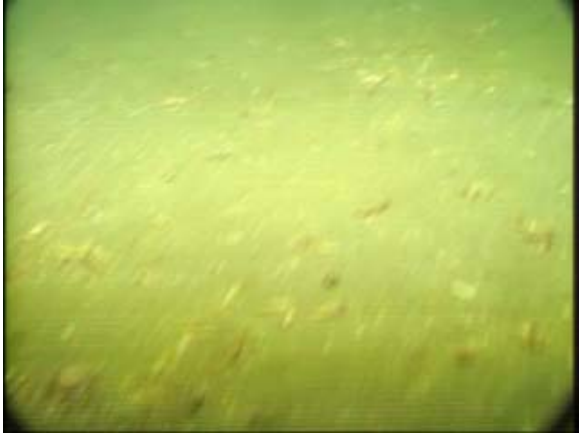
<p>08.30 – 10.00 16/08/2013</p>	<ul style="list-style-type: none"> <li>- Divers in water start survey the seabed around the STN-N07 point within the radius 65,70, 75, 80 meters</li> <li>- There are no any debris was detected</li> <li>- The seabed is a layer of hard sand under a thin layer of oyster shell, ephemeras and alluvium</li> </ul>

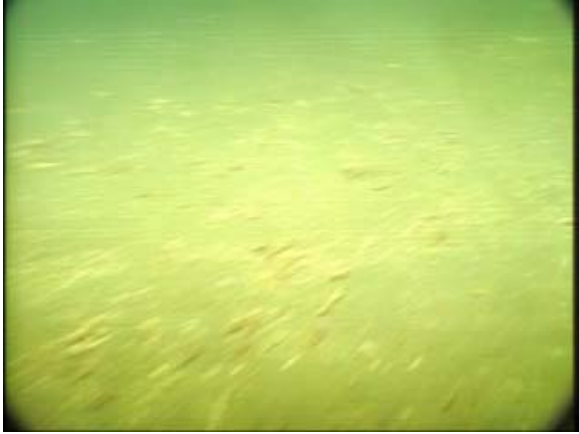
<p>06.20 – 07.30 15/08/2013</p>	<ul style="list-style-type: none"> <li>- Divers in water continue survey the seabed around the STN-N08 point within the radius 40, 45, 50, 55 meters</li> <li>- There are no any debris was detected</li> <li>- The seabed is a layer of hard sand under a thin layer of oyster shell, ephemerias and alluvium</li> </ul>

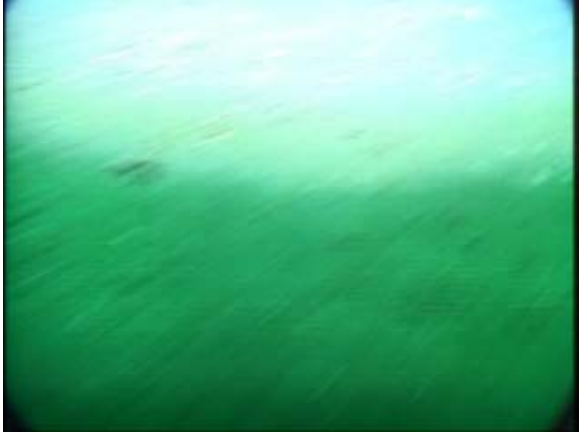
<p>07.35 – 09.00 15/08/2013</p>	<ul style="list-style-type: none"> <li>- Divers in water continue survey the seabed around the STN-N08 point within the radius 60, 65, 70 meters</li> <li>- There are no any debris was detected</li> <li>- The seabed is a layer of hard sand under a thin layer of oyster shell, ephemerias and alluvium</li> </ul>

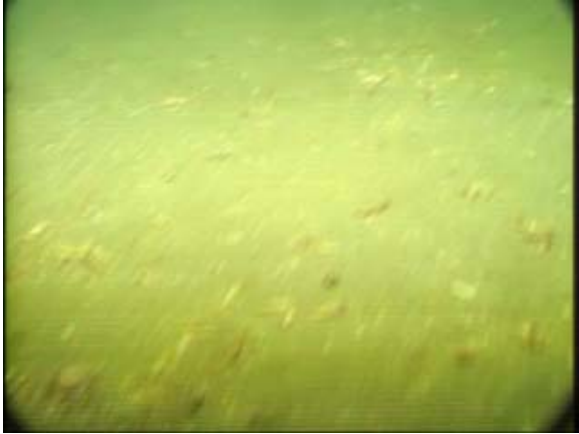
<p>09.00 – 10.00 15/08/2013</p>	<ul style="list-style-type: none"> <li>- Divers in water continue survey the seabed around the STN-N08 point within the radius 75, 80 meters</li> <li>- There are no any debris was detected</li> <li>- The seabed is a layer of hard sand under a thin layer of oyster shell, ephemerias and alluvium</li> </ul>

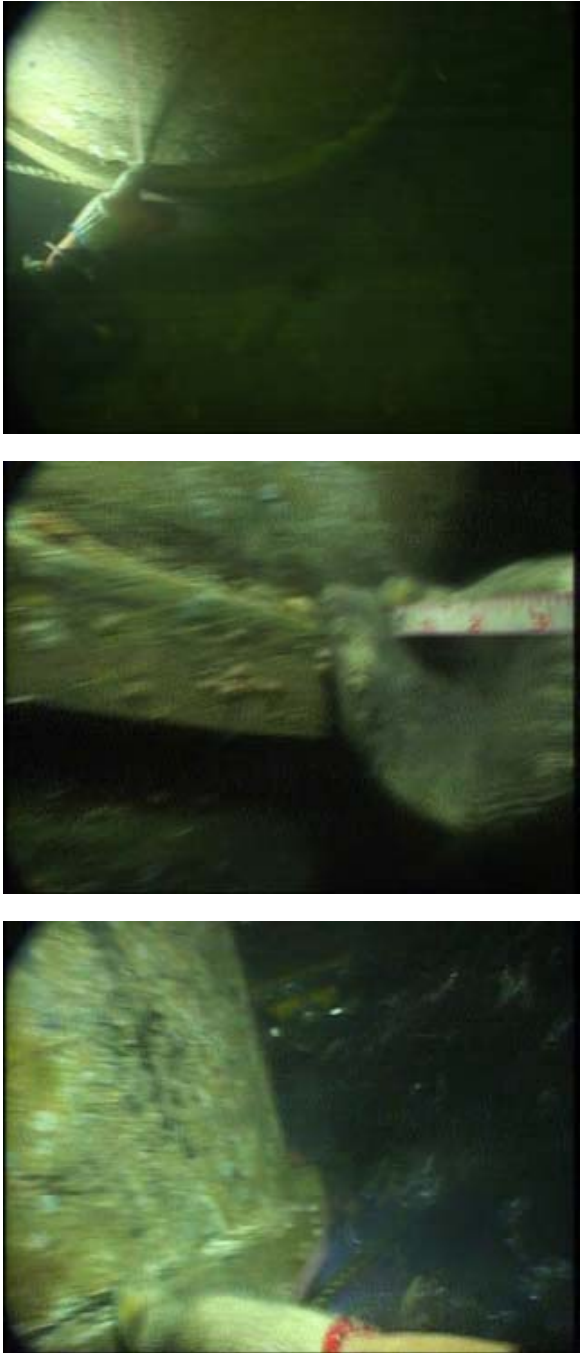
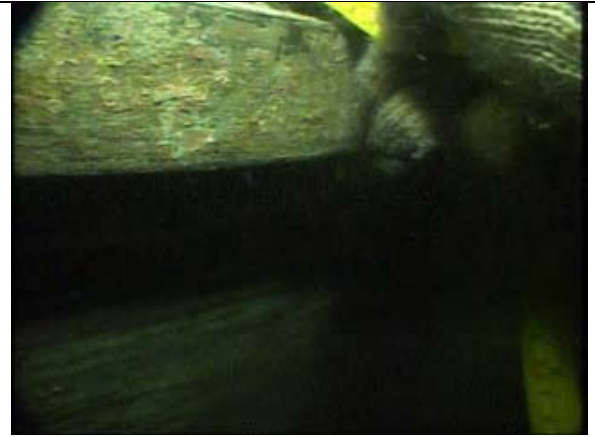
Date & time	Detail activities	Illustration
<p>07.30 – 12.00 17/08/2013</p>	<ul style="list-style-type: none"> <li>- Divers in water to GVI (general visual inspection) the wellhead No.5</li> <li>- The wellhead is in good condition when visual inspection</li> <li>- There are not any damage was detected on the wellhead</li> <li>- Divers clean the barnacle and marine growth around the wellhead</li> <li>- <b>Note:</b> the wellhead is not a smooth pipeline, divers confirm that there are 3 O-ring along the wellhead body (one of these O-ring is covered by trash cap). See the below section “3.c. wellhead mesurement” for more detail</li> </ul>

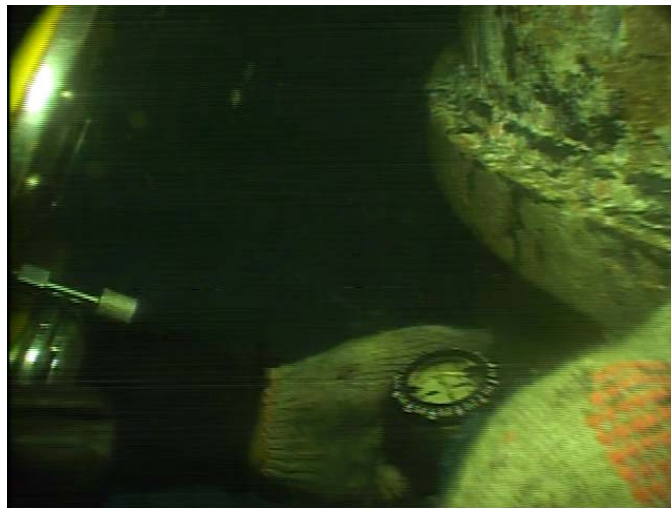
- Use the diving compass to determine the North, East, South, West of wellhead

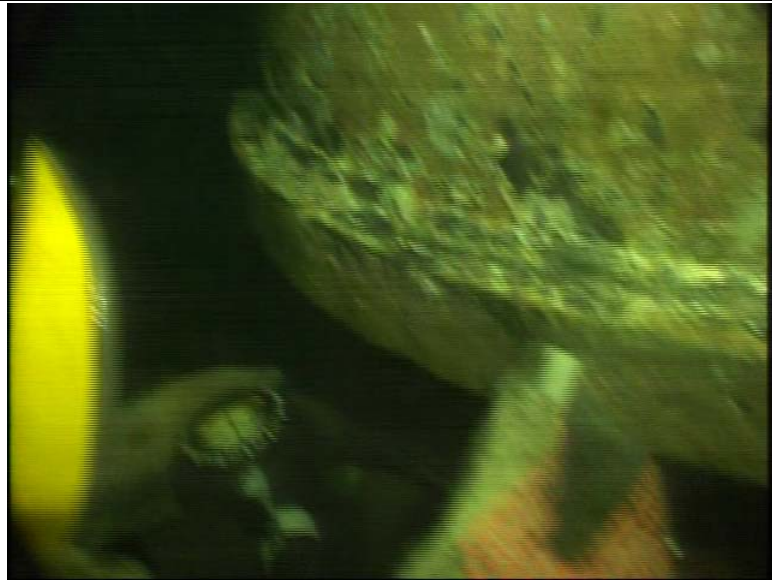
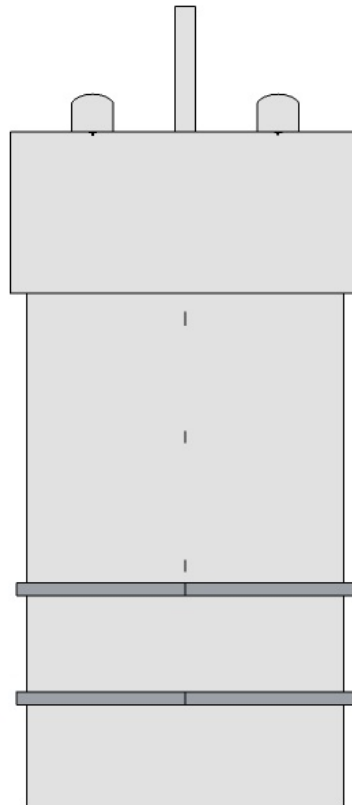
- Divers check and mark some point to determine the vertical line for putting the digital inclinometer

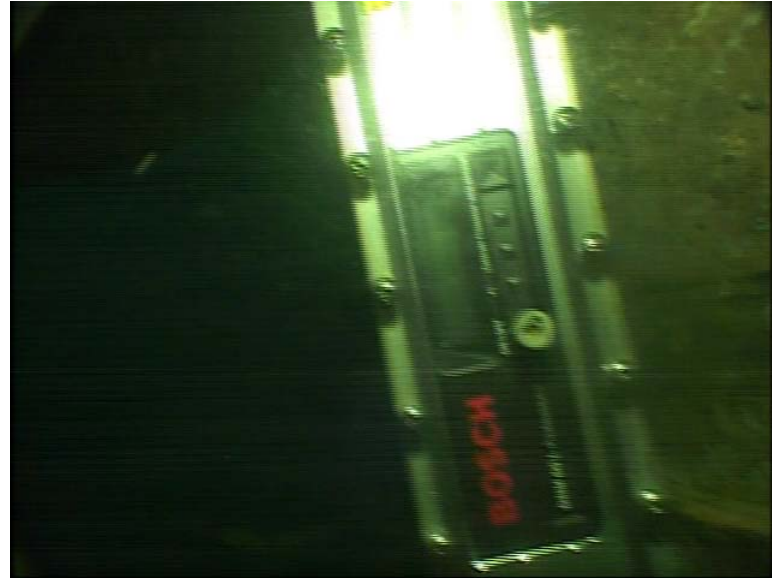
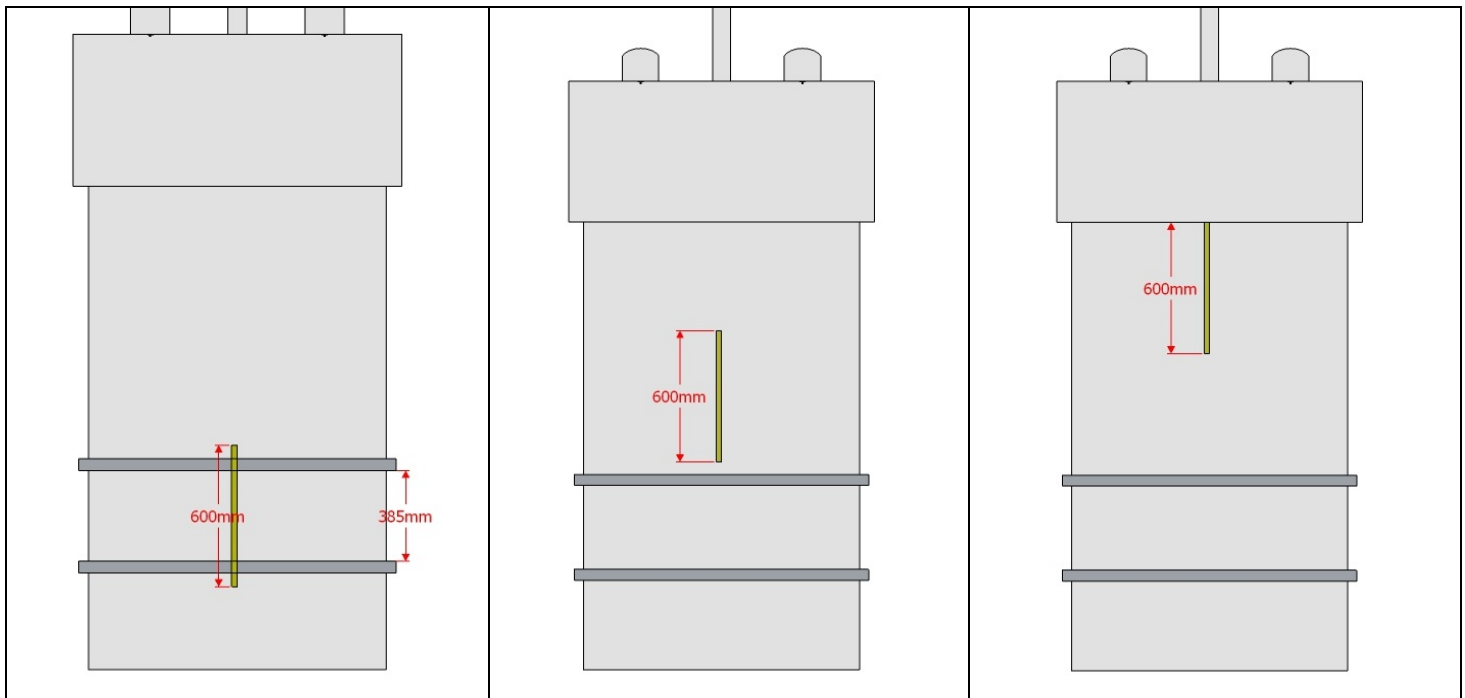
- Put the inclinometer to the vertical line to check the tilt

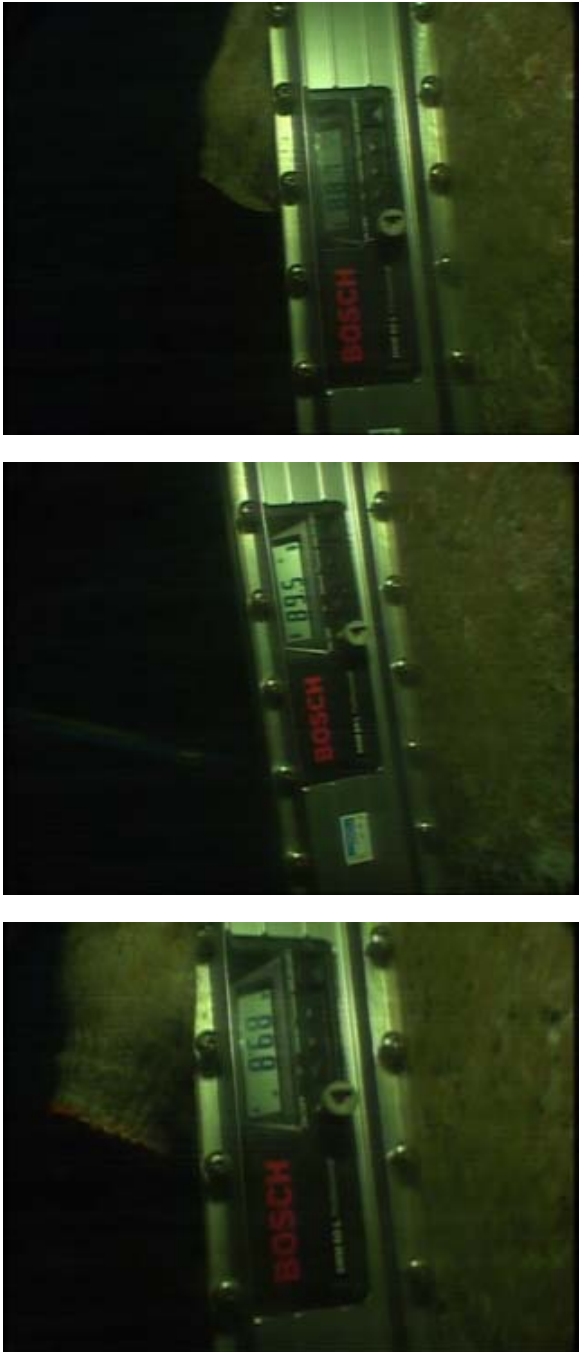
Date & time	Detail activities	Illustration
<p>17.30 – 18.30 17/08/2013</p>	<ul style="list-style-type: none"> <li>- Divers use diving compass to determine the <b>North of wellhead</b></li> <li>- Make the vertical line on the wellhead body</li> <li>- Divers put the digital inclinometer 3 times on the wellhead body (view above picture) to check the tilt of the wellhead               <ul style="list-style-type: none"> <li>• Putting inclinometer the first time, the angle value display on inclinometer: 88.7°</li> <li>• Putting inclinometer the second time, the angle value display on inclinometer: 89.5°</li> <li>• Putting inclinometer the third time, the angle value display on inclinometer: 89.8°</li> </ul> </li> </ul> <p><b>Note:</b> for more detail please view DVD report</p>

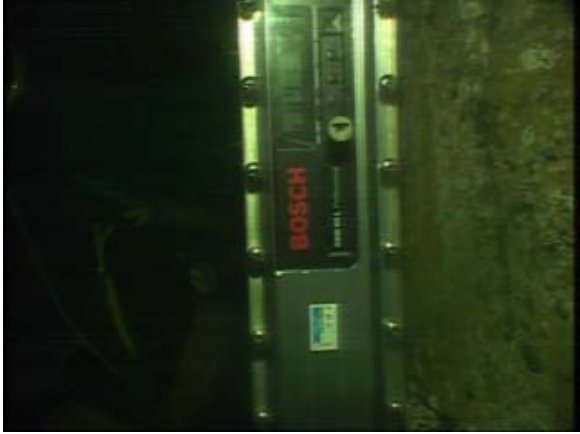
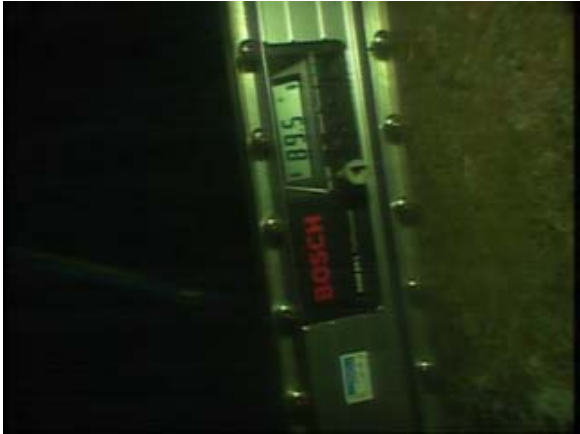
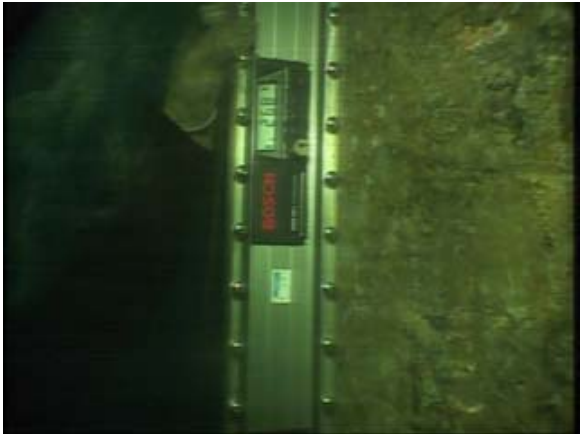
<p>17.30 – 18.30 17/08/2013</p>	<ul style="list-style-type: none"><li>- Divers use diving compass to determine <b>the East of wellhead</b></li><li>- Make the vertical line on the wellhead body</li><li>- Divers put the digital inclinometer 3 times on the wellhead body to check the tilt of the wellhead<ul style="list-style-type: none"><li>• Putting inclinometer the first time, the angle value display on inclinometer: 89.1°</li><li>• Putting inclinometer the second time, the angle value display on inclinometer: 89.5°</li><li>• Putting inclinometer the third time, the angle value display on inclinometer: 89.2°</li></ul></li></ul> <p><b>Note:</b> for more detail please view DVD report</p>

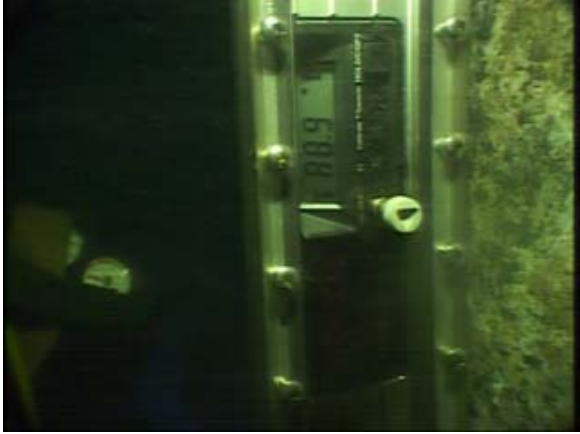
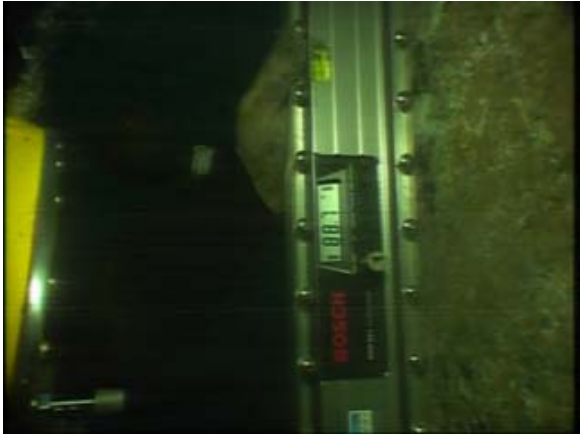
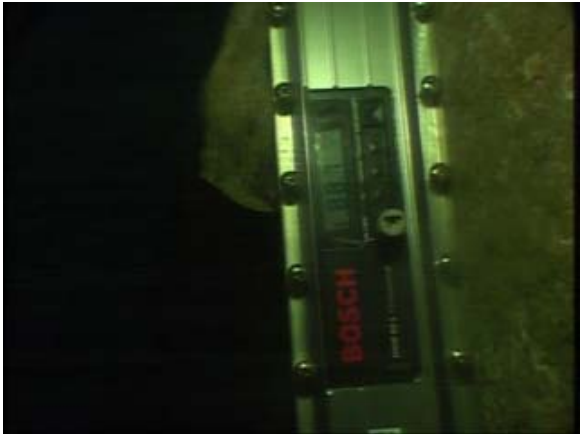
<p>17.30 – 18.30 17/08/2013</p>	<ul style="list-style-type: none"> <li>- Divers use diving compass to determine the <b>South of wellhead</b></li> <li>- Make the vertical line on the wellhead body</li> <li>- Divers put the digital inclinometer 3 times on the wellhead body to check the tilt of the wellhead             <ul style="list-style-type: none"> <li>• Putting inclinometer the first time, the angle value display on inclinometer: 88.9°</li> <li>• Putting inclinometer the second time, the angle value display on inclinometer: 88.7°</li> <li>• Putting inclinometer the third time, the angle value display on inclinometer: 88.7°</li> </ul> </li> </ul> <p><b>Note:</b> for more detail please view DVD report</p>

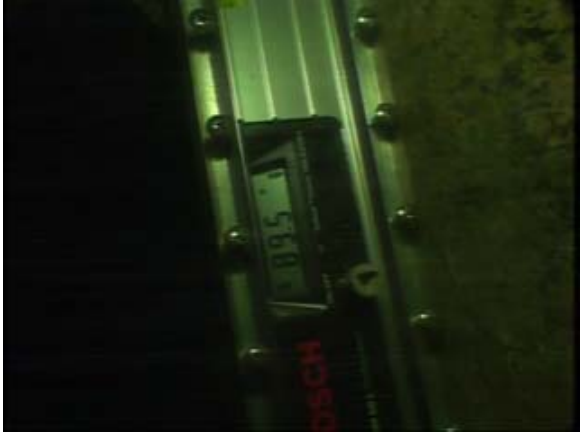
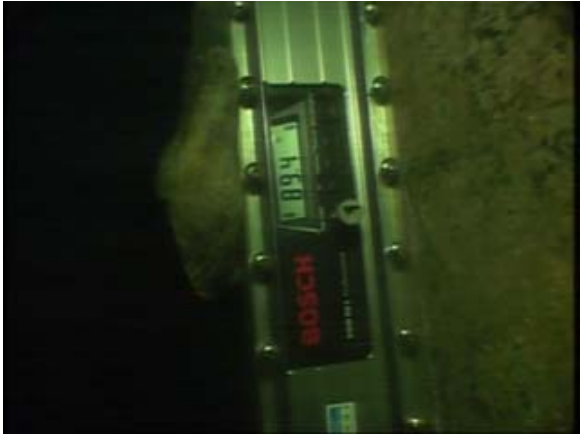
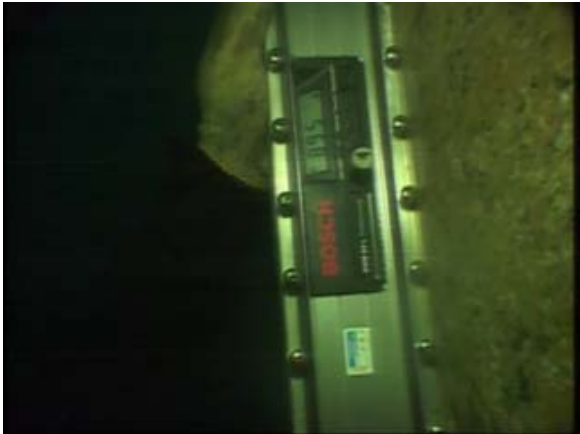
<p>17.30 – 18.30 17/08/2013</p>	<ul style="list-style-type: none"><li>- Divers use diving compass to determine the <b>West of wellhead</b></li><li>- Make the vertical line on the wellhead body</li><li>- Divers put the digital inclinometer 3 times on the wellhead body to check the tilt of the wellhead<ul style="list-style-type: none"><li>• Putting inclinometer the first time, the angle value display on inclinometer: 89.5°</li><li>• Putting inclinometer the second time, the angle value display on inclinometer: 89.4°</li><li>• Putting inclinometer the third time, the angle value display on inclinometer: 89.5°</li></ul></li></ul> <p><b>Note:</b> for more detail please view DVD report</p>

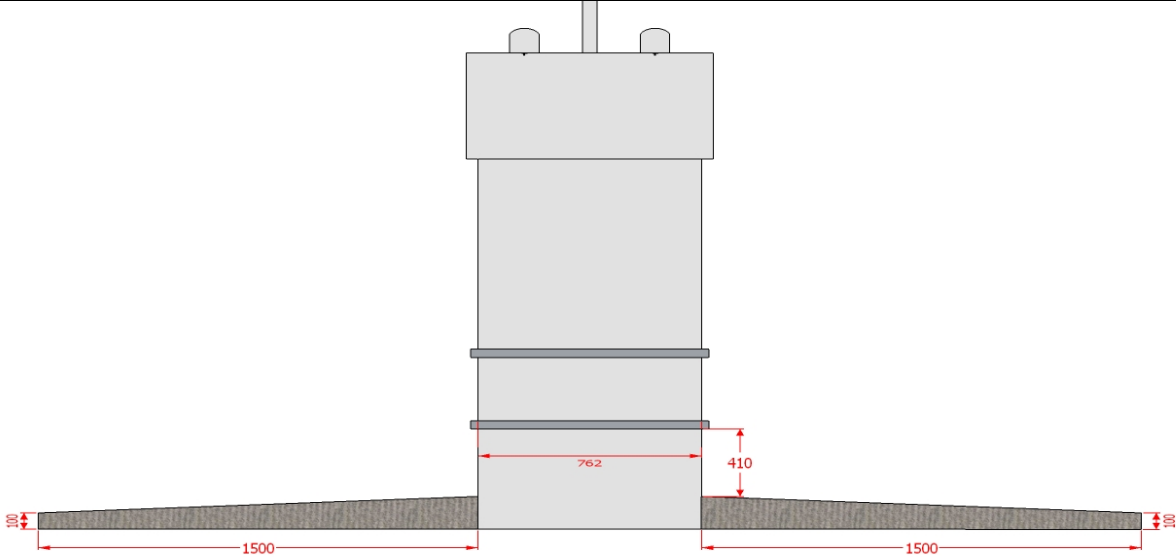
<b>Date &amp; time</b>	<p>07.30 – 09.20 18/08/2013</p>
<b>Detail activities</b>	<ul style="list-style-type: none"> <li>- Divers in water to set up the alignment rope and put the numbering plate</li> <li>- Divers measure the the concrete around wellhead No.5             <ul style="list-style-type: none"> <li>o The radius of concrete around wellhead is about 1.5m</li> <li>o The most thickness at our side is about 10cm</li> <li>o The thickness of concrete at wellhead leg is cannot checked</li> </ul> </li> </ul>
<b>Illustration</b>

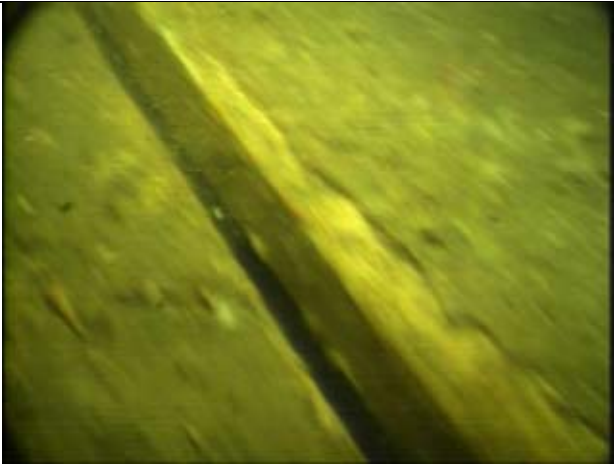
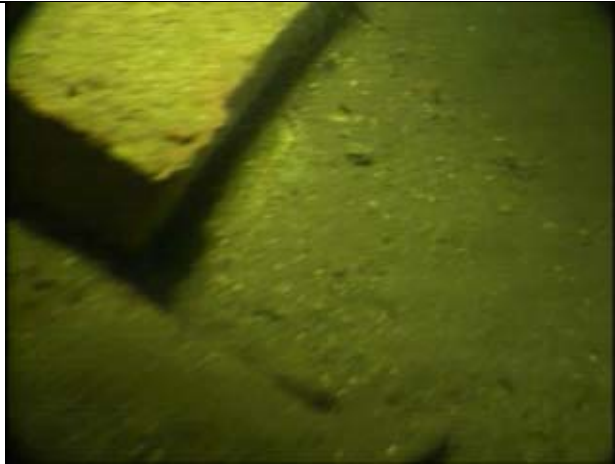
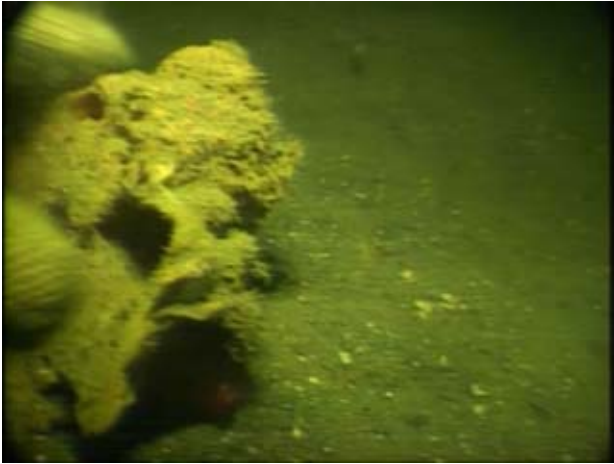
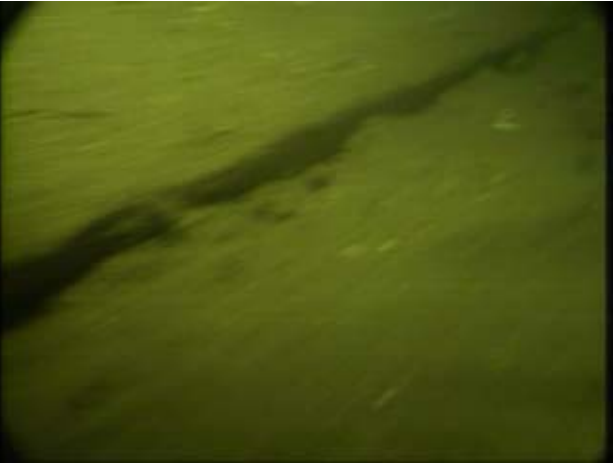
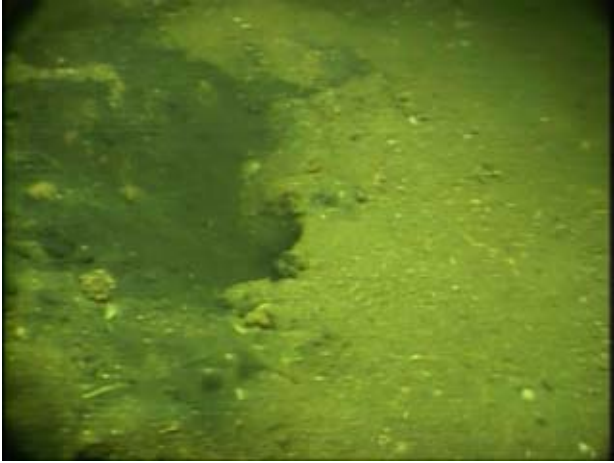
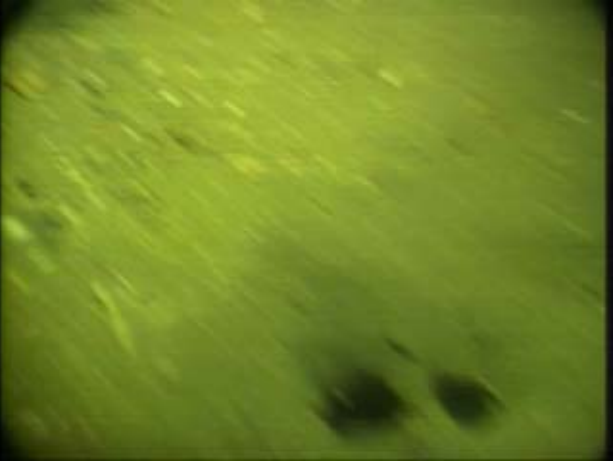
Illustration

<b>Date &amp; time</b>	<p>09.30 – 11.20 18/08/2013</p>
<b>Detail activities</b>	<ul style="list-style-type: none"> <li>- Second diving team in water to survey around the wellhead within 30m radius</li> <li>- Some small debris was detected, include:             <ul style="list-style-type: none"> <li>o 02 wire ropes 32mm with a shackle around wellhead</li> <li>o 01 small steel pipe</li> </ul> </li> <li>- And the small debris was removed by divers</li> <li>- Divers also detect 3 big steel plates, the thickness of each plate is 22mm and it is not yet picked up</li> <li>- From the radius 15 to 30m:             <ul style="list-style-type: none"> <li>o There are no any debris was detected</li> <li>o The seabed is a layer of sand under a thin layer of oyster shell, ephemeras and alluvium</li> </ul> </li> </ul>

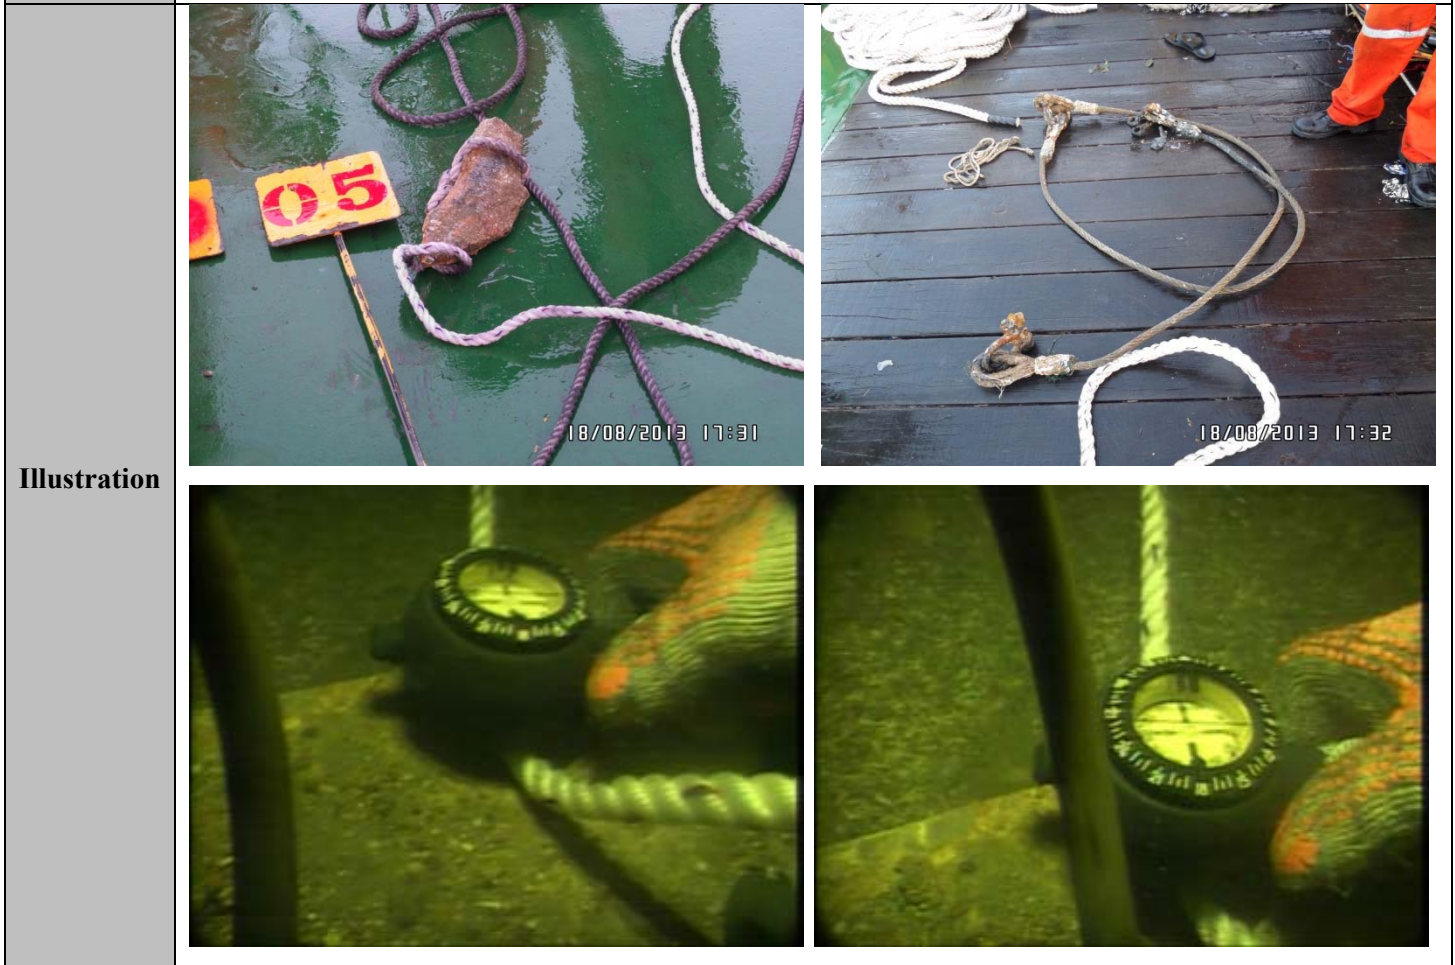
Date & time	16.30 – 17.30 18/08/2013	
Detail	- Divers in water to determine the position of steel plate, remove small debris

| <b>activities</b> | <ul style="list-style-type: none"><li>- From the wellhead to the steel plates is about 5m follow the North (determine by diving compass)</li><li>- The coordinate of the steel plates is: N 1168622m – E 872304m (determine by GPS Navigation and positioning)</li><li>- Almost surface of the steel plates are covered by a deep sand layer so divers cannot take the exact measurement</li></ul> |

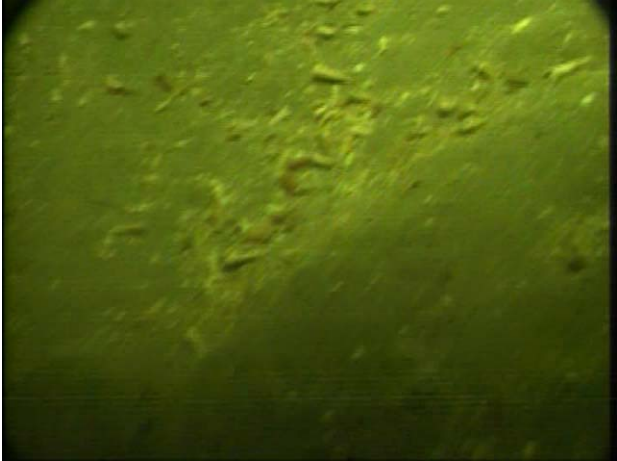
<p>06.40 – 07.50 20/08/2013</p>	<ul style="list-style-type: none"> <li>- Divers survey seabed around STN-S05 point within radius from 15 to 40m</li> <li>- There are not any debris was detected</li> <li>- The seabed is a layer of sand under a thin layer of oyster shell, ephemeras and alluvium</li> <li>- The seabed is not flat and has a lot of small mound</li> </ul>

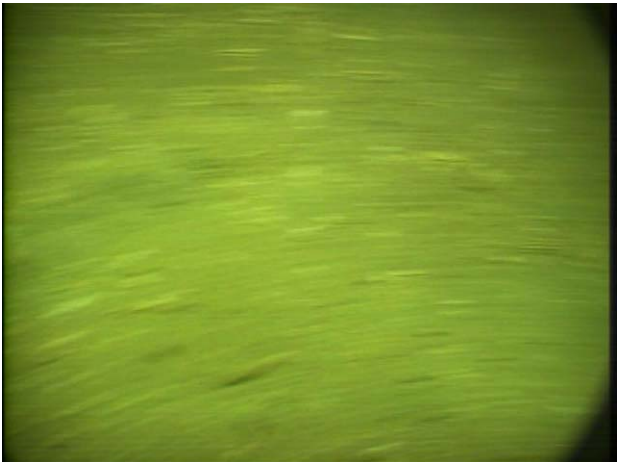
<p>07.50 – 09.00 20/08/2013</p>	<ul style="list-style-type: none"> <li>- Divers survey seabed around STN-S05 point within radius from 45 to 60m</li> <li>- There are not any debris was detected</li> <li>- The seabed is a layer of sand under a thin layer of oyster shell, ephemeras and alluvium</li> <li>- The seabed is not flat and has a lot of small mound</li> </ul>

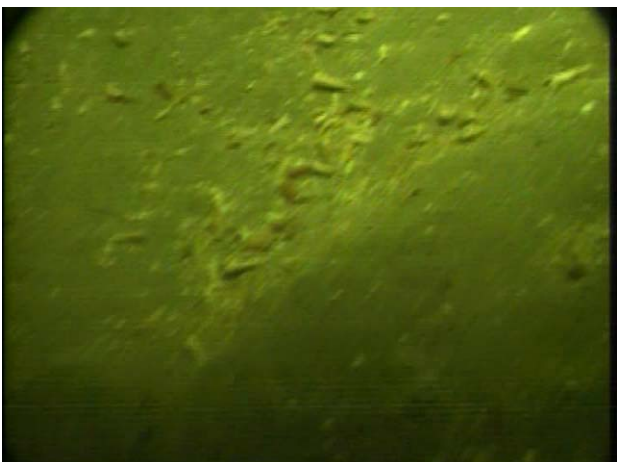
<p>09.00 – 10.10 20/08/2013</p>	<ul style="list-style-type: none"> <li>- Divers survey seabed around STN-S05 point within radius from 65 to 70m</li> <li>- There are not any debris was detected</li> <li>- The seabed is a layer of sand under a thin layer of oyster shell, ephemeras and alluvium</li> <li>- The seabed is not flat and has a lot of small mound</li> </ul>

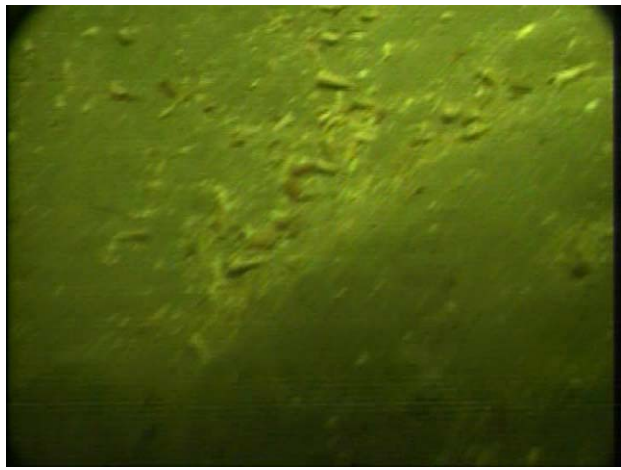
<p>09.00 – 10.00 21/08/2103</p>	<ul style="list-style-type: none"> <li>- Divers survey seabed around STN-S07 point within radius from 15 to 40m</li> <li>- There are not any debris was detected</li> <li>- The seabed is a layer of sand under a thin layer of oyster shell, ephemerias and alluvium</li> <li>- The seabed is not flat and has a lot of small mound</li> </ul>

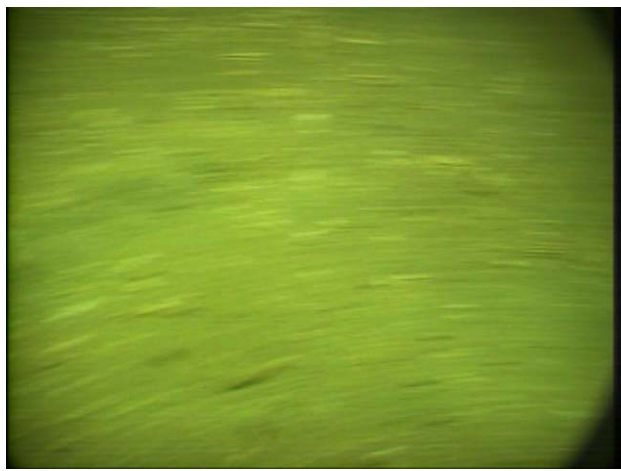
<p>10.00 – 11.00 21/08/2103</p>	<ul style="list-style-type: none"> <li>- Divers survey seabed around STN-S07 point within radius from 45 to 60m</li> <li>- There are not any debris was detected</li> <li>- The seabed is a layer of sand under a thin layer of oyster shell, ephemerias and alluvium</li> <li>- The seabed is not flat and has a lot of small mound</li> </ul>

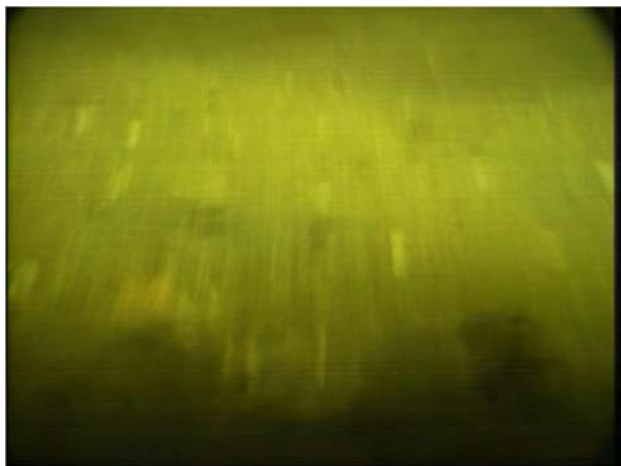
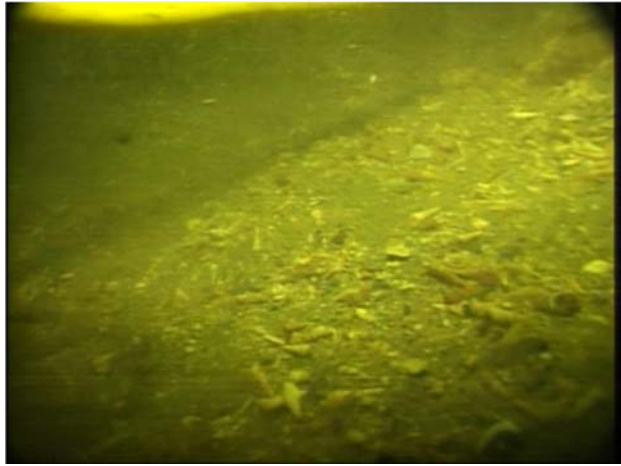
<p>09.30 – 11.30 19/08/2013</p>	<ul style="list-style-type: none"> <li>- Divers survey seabed around STN-S08 point within radius from 5 to 40m</li> <li>- There are not any debris was detected</li> <li>- The seabed is a layer of sand under a thin layer of oyster shell, ephemeras and alluvium</li> <li>- The seabed is not flat and has a lot of small mound</li> </ul>

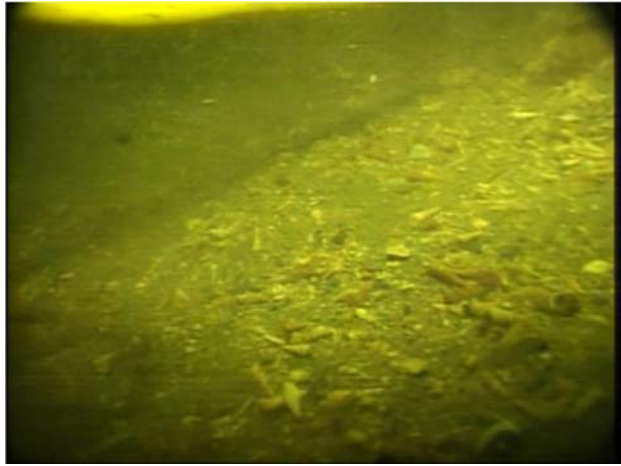
<p>18.00 – 20.00 19/08/2013</p>	<ul style="list-style-type: none"> <li>- Divers survey seabed around STN-S08 point within radius from 45 to 70m</li> <li>- There are not any debris was detected</li> <li>- The seabed is a layer of sand under a thin layer of oyster shell, ephemeras and alluvium</li> <li>- The seabed is not flat and has a lot of small mound</li> </ul>
